Title: CONTINUING AIRWORTHINESS FOR ECI INTERCYLINDER COOLING BAFFLES

Issued: 02/28/05

Revision: 1

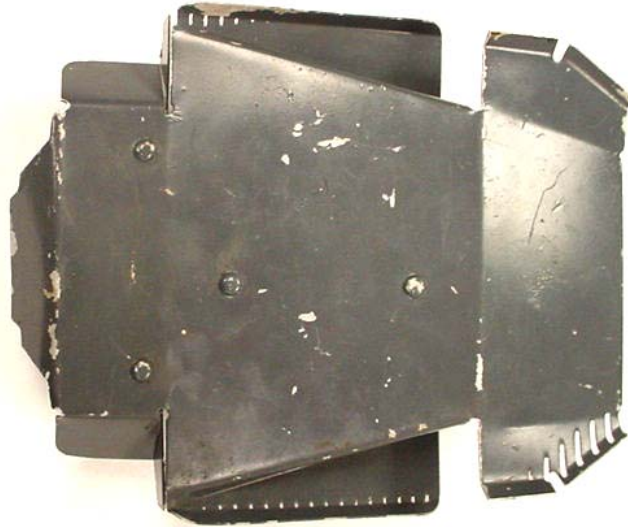
At annual inspection, one should thoroughly inspect baffles for corrosion and wear due to rubbing on the cylinder head and barrel. Typically, baffles will last for many hours of operation if they are installed properly. However, excessive wear is evident by grooves puncturing the baffle such as shown in Figure 1. If the baffle shows corrosion or excessive signs of wear, it should be replaced.

Figure 1: Lycoming baffle showing excessive signs of wear
