Title: MANDATORY BEARING INSPECTION/RECALL

Issued: **10/01/04**

Revision: **1**

Service Instruction No. 04-9 Revision 1

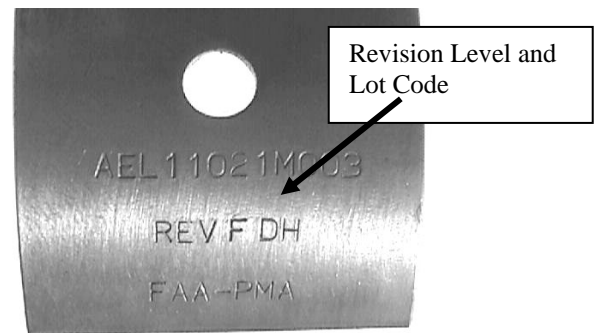
- Determine if any AEL13884 STD Rev. G, AEL11021 STD or M003 Rev. F or AEL13521 STD Rev. D replacement bearings for Lycoming engines have been purchased from ECi since June 1, 2004. The bearings may be further identified by the lot code stamped on the back of the bearing halves as shown in the photograph at the right and on the next page. The Rev. level and Lot Code are also stamped on the label affixed to the box in which the bearings are packaged.

2. If AEL13884 STD, AEL11021 STD or M003 or AEL13521 STD bearings have been purchased from ECi since June 1, 2004 and not installed in an engine, and if the bearings are marked with Lot Code “CH” or “DH”, return these bearings to ECi for credit or replacement.

3. If AEL13884 STD, AEL11021 Std. & M003 or AEL13521 Std. bearings have been purchased from ECi between June 1, 2004 and September 17, 2004 and are installed in an engine, the engine oil screen and oil filter should be carefully checked by examining for excessive metal flakes as detailed in *Lycoming Service Bulletin Number 480D*. Further, if a significant number of flakes are found, check to see if they are magnetic. A nickel layer under the overlay will make the bearing overlay flakes magnetic. If the flakes are not magnetic, then they are from another source.
