Service Bulletin

Title: **Cylinder Barrel Fillet Inspection**

SB No.: **10-11**

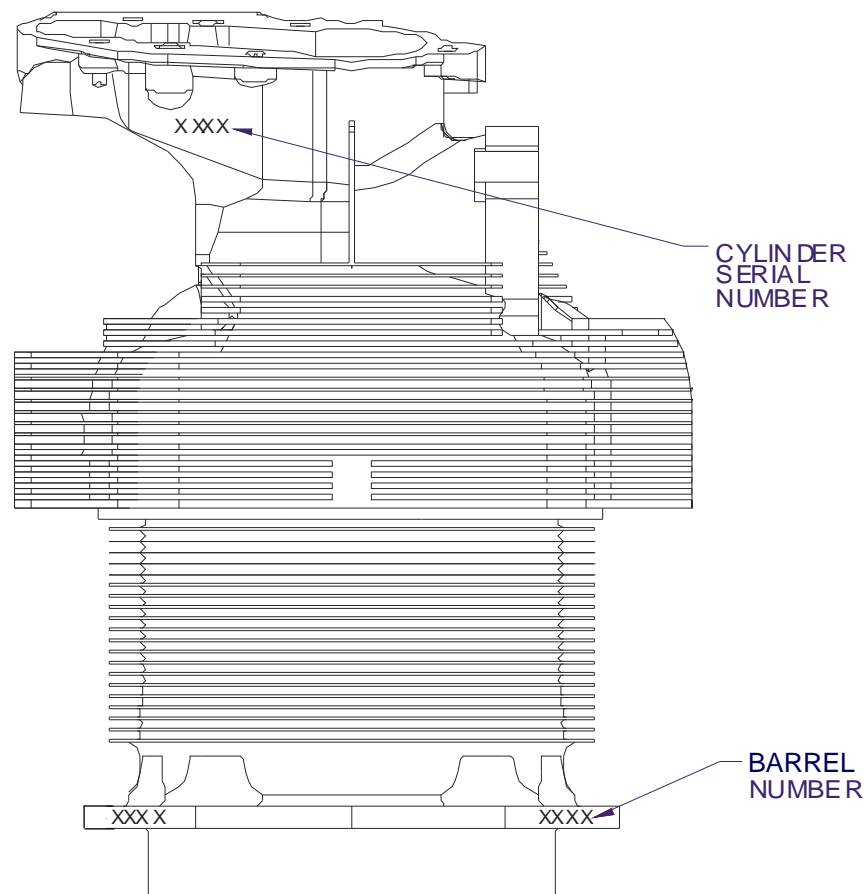
Figure 1: Location of markings for cylinder assemblies affected by this Service Bulletin

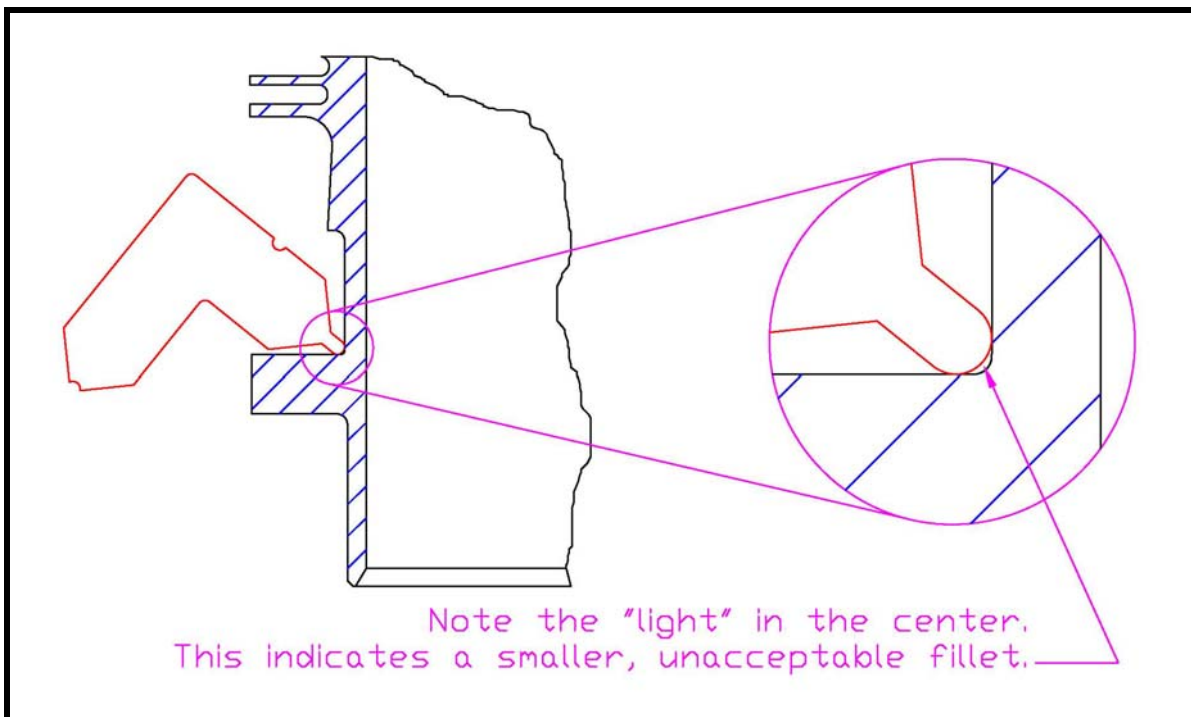
The original design data requires that the minimum fillet be .040. Due to improper installation of the cutting tool in production, the possibility exists that as many as 15 cylinders have similar fillets. To ensure continued operational safety, ECi has elected to require an inspection of two production lots that may be potentially affected with the same defect.

Figure 2: Drawing showing an unacceptable barrel fillet.

7. For those cylinders found to exhibit a fillet less than .040, remove and return to ECi for a replacement cylinder. Please contact ECi Customer Service at 800-ECi-2Fly (800-324-2359) for further information.

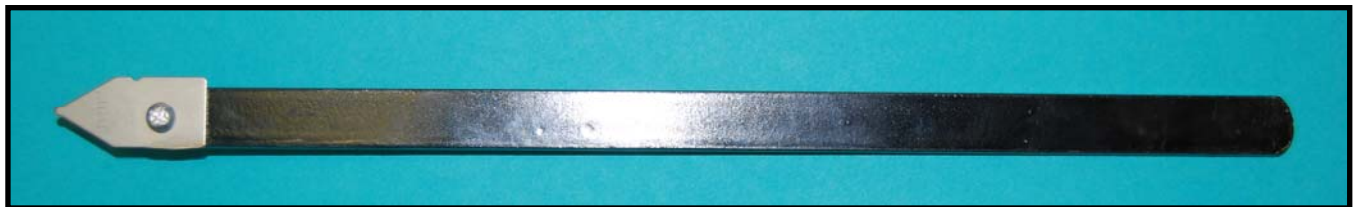
Photograph 1:

Radius Gage with Extension

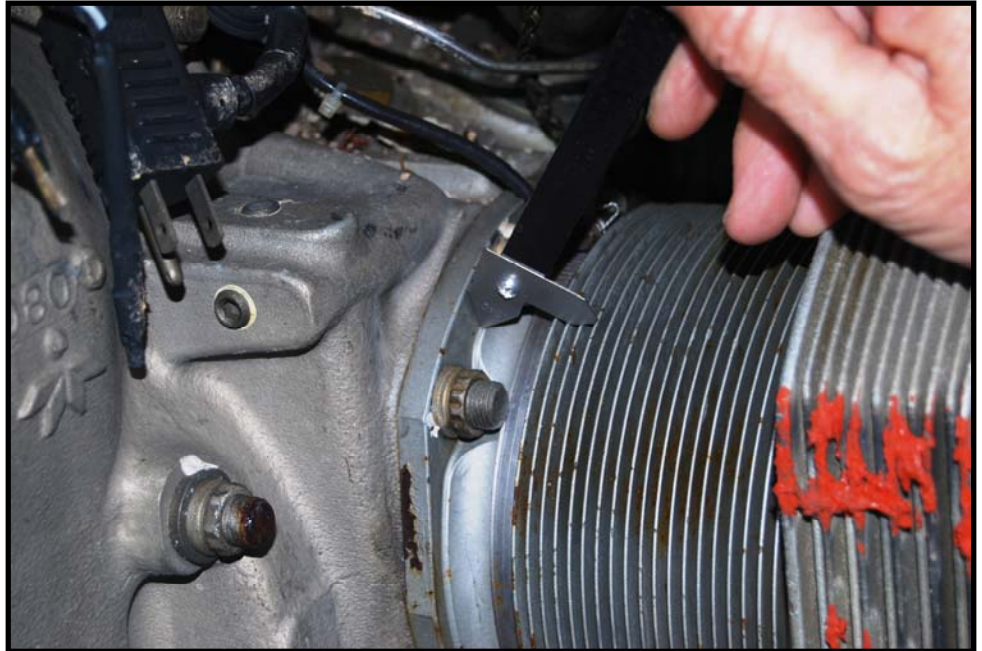
Photograph 2:

Radius gage attached to an extension to aid in the inspection. This photograph shows an acceptable fillet.

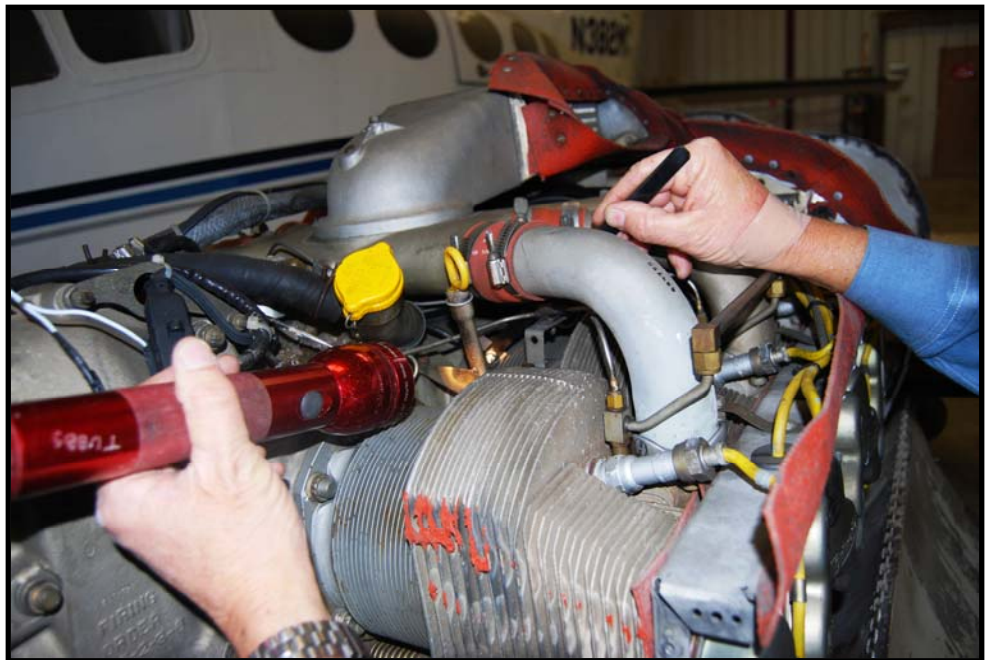
Photograph 3:

Inspection of fillet on cylinder #4. The radius gage extension allows the gage to be positioned for inspection.
