# Service Information Bulletin

**Title: Effect of Over Temperature Operation and High Piston Blow-By on Cylinder Safety**

SIB No.: 12-2  
Page: 1 of 8  
Issued: 12/04/2012  
Revision: 0

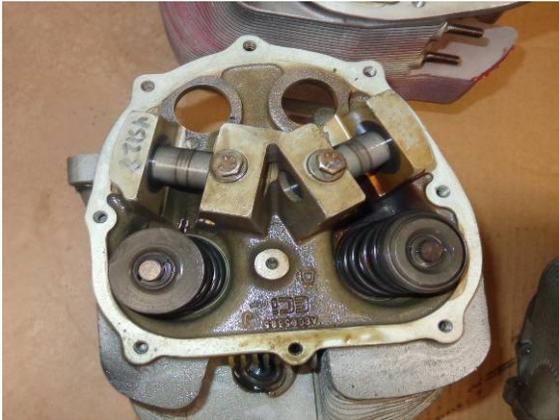
*Photograph 4*

Photograph 4 shows a cylinder with normal darkening in the rocker box after return for overhaul. Some darkening around the valve spring pockets is normal for the hours of operation. Photograph 5 shows a cylinder that has been operating very hot for an extended time frame. A cylinder that has been operated within thermal limits is shown in Photograph 6, and a cylinder that was known to be operating at and above CHT limits for an extended time period is shown in Photograph 7.

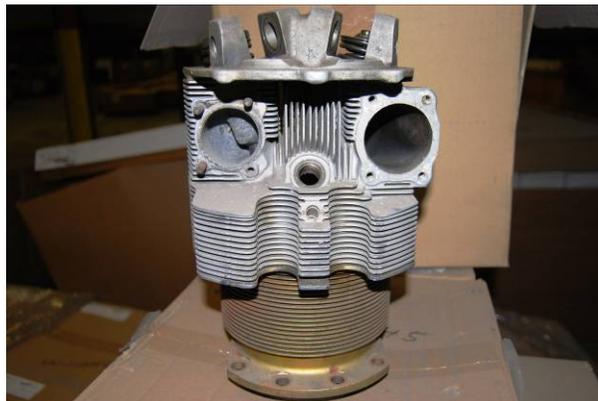
*Photograph 6*

The area of the cylinder head around the spark plugs and the fin area around the exhaust port sometimes provides clear evidence of over-temperature operation. The visual clues can be caused by a leaking exhaust gasket, but can also be evidence of over-heating. Burned paint around the spark plugs on Lycoming cylinders or discoloration on Continental cylinders should be investigated to insure that high cylinder temperatures do not adversely affect air worthiness. High temperature indications around spark plugs can be caused by spark plugs that were not correctly torqued, or were somehow loosened, or by spark plugs with cracked insulators. There are other causes, but this condition should be investigated.

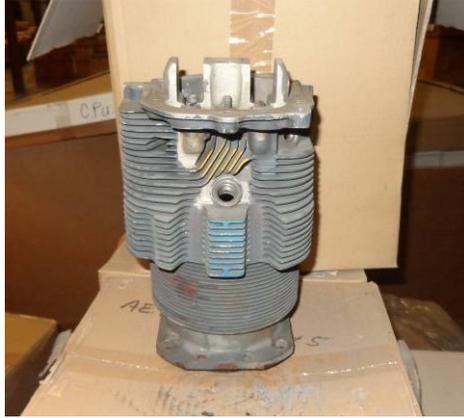
*Photograph 8*

Photograph 8 shows a normal appearance for Lycoming parallel valve engines, and Photograph 9 shows a cylinder that experienced high over temperatures.

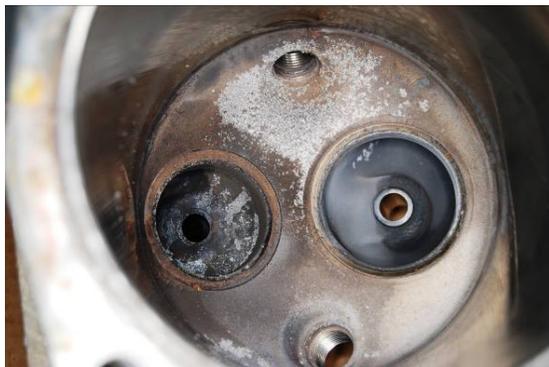
*Photograph 10*

Photograph 10 and 11 show a cylinder combustion chamber and piston that experienced detonation and possibly pre-ignition. Minor detonation can be tolerated for a short period, but it can grow in intensity as it heats surfaces in

the combustion chamber. The piston shown in Photograph 11 came from the cylinder shown in Photograph 10. The products of detonation and pre-ignition include splatters of bead-like deposits on the piston dome and on the combustion chamber.

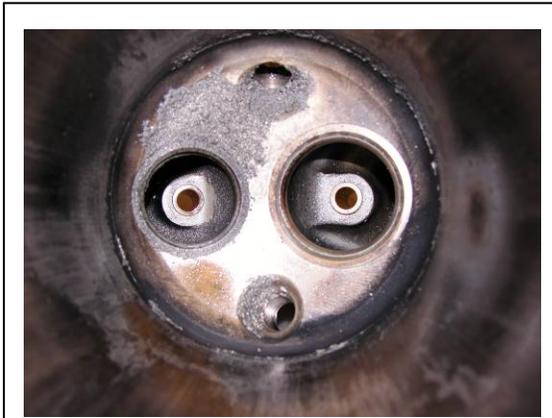
*Photograph 12*

Photograph 12 and 13 show another cylinder combustion chamber and the installed piston that experienced heavy detonation and/or pre-ignition.

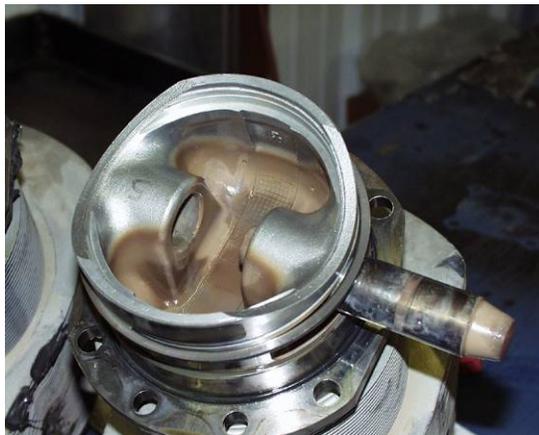
*Photograph 14*

One of the first places to look for evidence of over temperature operation is the underside of a piston. The underside of a piston is splashed and sprayed with engine oil during operation, and if the piston is operating too hot, which is usually caused by blow-by, but also high cylinder temperatures, then the oil will oxidize and deposit a coating of varnish, carbon and heavy oil as shown in Photograph 15. Photograph 14 shows a piston that operated for more than 350 hours during certification testing with the majority of the testing performed at 460 °F cylinder head temperatures.

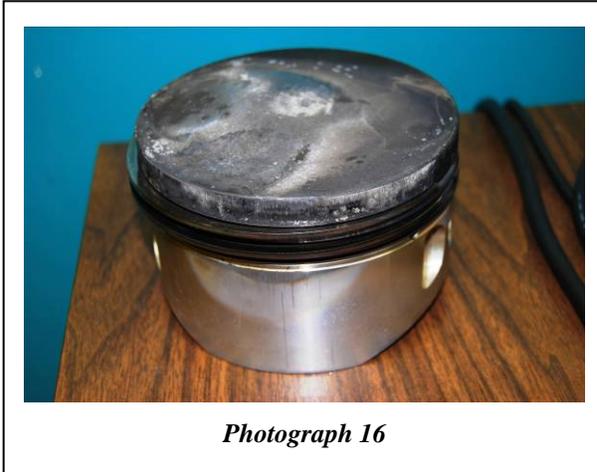
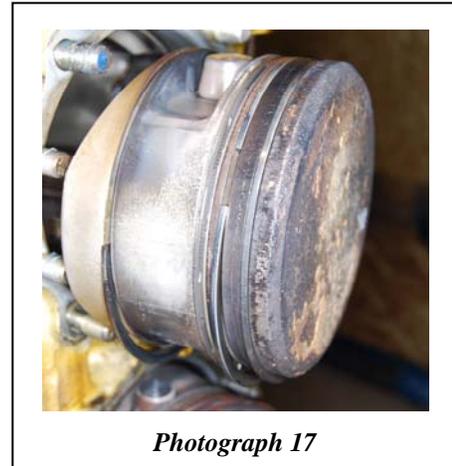
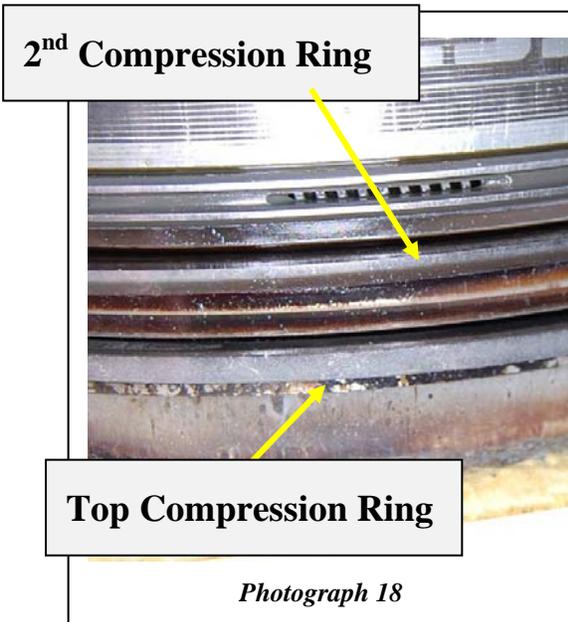
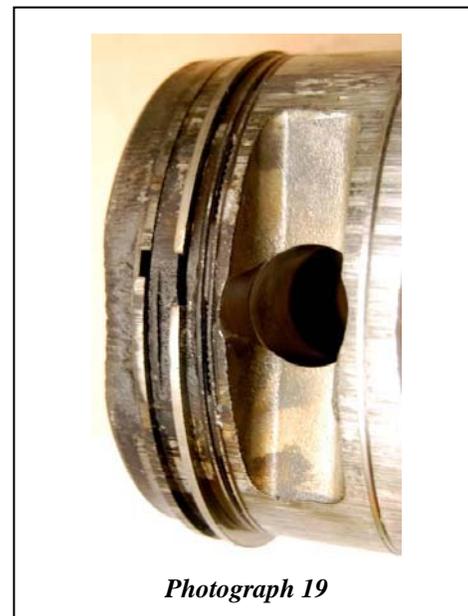
The outside of the piston can also tell a good story about the operating conditions. Photograph 16 shows a piston subjected to FAA endurance and durability testing. A total of 400 operating hours with the majority at CHT limits. Some minor detonation evidence is found on the dome, which probably occurred during detonation testing. Photograph 17 shows a low time piston that was overheated and experienced high blow-by.

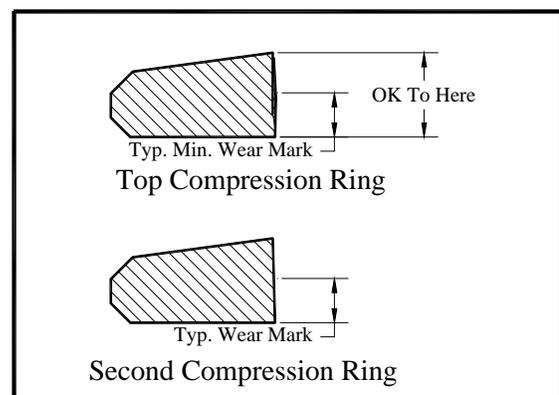
The piston rings installed on a Piston for a Continental engine shown in Photograph 18 exhibit normal wear. The top ring has a molybdenum face, and close examination shows that the wear band extends from the bottom of the ring almost completely across the face. The second compression ring has a wear band that is about  $\frac{1}{4}$  across the ring face. The scraper ring was installed with the taper toward the top of the piston, and the wear band is almost  $\frac{1}{2}$  the distance from the top of the ring toward the bottom. The scraper ring has a much sharper face taper than the compression rings, and will bed in faster than the compression rings.
