Service Bulletin

Title: **Inspection of Barrel Fin Depth**

SB No.: **13-2**

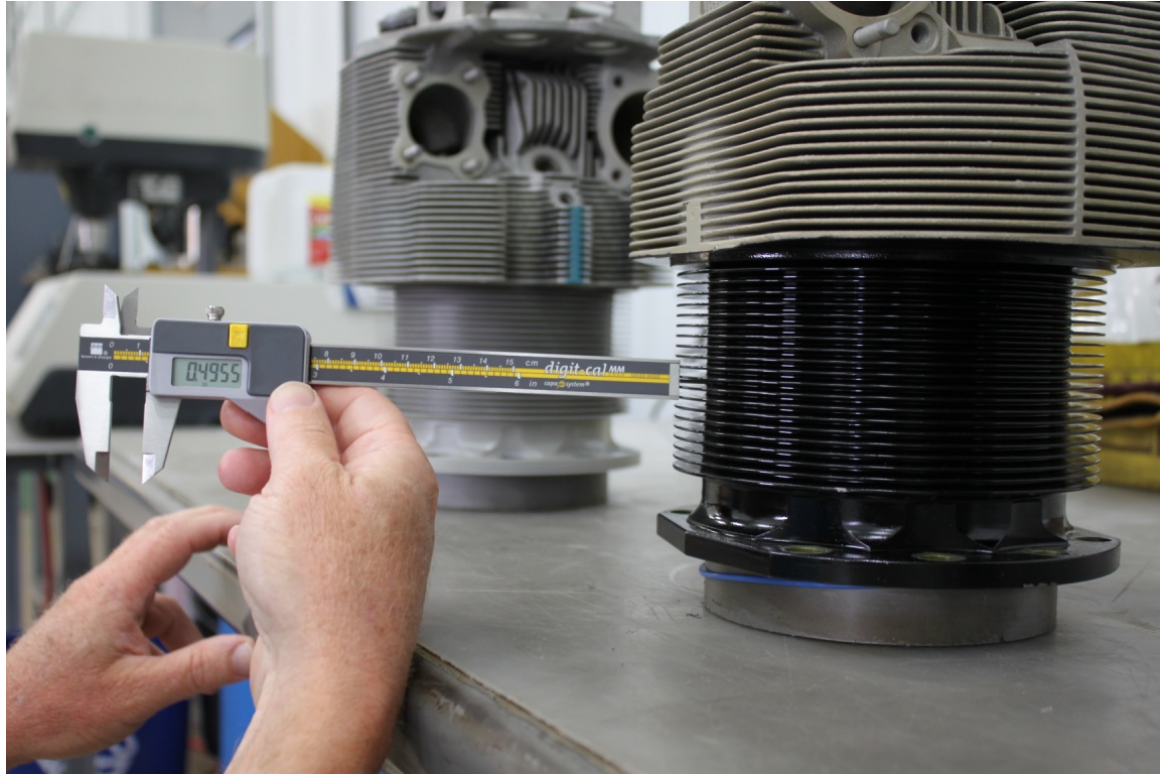
- 3.0 The Serial Number of the cylinder that has not been inspected is **93346-04**.
- 4.0 Inspection and Compliance: The part of the cylinder assembly affected is the cylinder barrel outer diameter between the barrel fins. The cylinder barrel may be measured using a vernier or digital caliper as shown in Photograph 1. **It is not necessary to remove the cylinder from the engine to perform this inspection.** The measurement should be accomplished at least three times between different fins, but all toward the middle of the fin pack. Do not measure the lowest four fin gaps above the cylinder barrel flange. The maximum distance from the outside diameter of the fins to the root should be 0.51 inches. If the measurement from the outside diameter of the fins to the fin root is more than 0.51 inches, contact ECI Customer Service for disposition and an RMA.

Photograph 1
Measuring Fin Depth Using A Caliper
