# Service Instruction

ENGINE COMPONENTS, INC.

S.I. No.: 86-1-1

Title: CYLINDER ASSEMBLY VALVE TRAIN

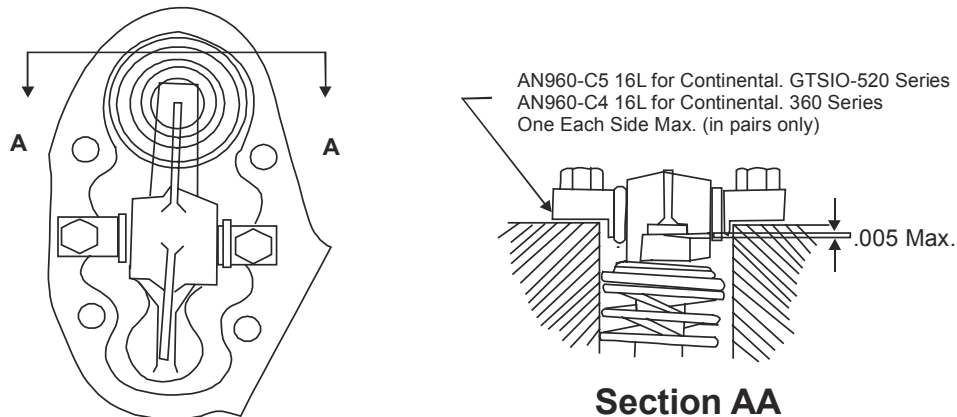
1. Grinding through the hard surface of the rocker arm.
2. Grinding an improper radius
3. Grinding an angle between the rocker arm and valve (or rotator)

Engine Components, Inc. has developed FAA approved repair procedures that assure airworthiness. However, item No. 3 does not become apparent until assembly with the cylinder, and can create excessive valve and guide wear. Fortunately, it is relatively easy to check. The illustrations show our recommended maximum misalignment between valves and rocker arms, regardless of engine type.

**ROCKER ADJUSTMENT:** Several approved repair techniques have an effect on valve train fits. One difficulty that occasionally is found is that valve clearance is reduced as a result of crankcases, cylinder, rocker arm, camshaft and cam follower repair. For many engines, adjustment is very difficult. For the Continental IO-TSIO-360 and GTSIO-520 series, however, a very slight adjustment can be accomplished by placing AN960-C416L or AN960-C516L washers on each side between the rocker shaft flat and cylinder. More than one washer should not be used on each side, and clearance for the gasket and rocker cover must be assured. It is essential to check rocker arm and valve alignment as shown above.
