Service Instruction

ENGINE COMPONENTS, INC.

S.I. No.: **98-5-2**

Title: ALTERNATE MEANS OF COMPLIANCE: CRANKSHAFT GEAR RECESS REPAIR

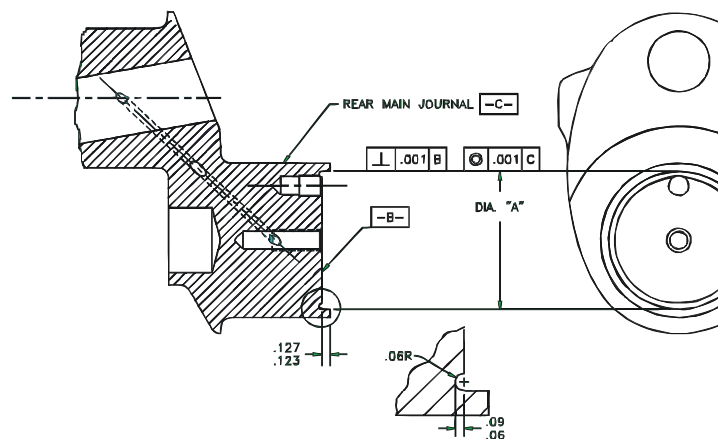
The repair procedure is to machine or grind the crankshaft gear pilot bore (Diameter "A" in the illustration below) to one of the oversize dimensions shown in Table 1. The pilot bore diameter must be maintained perpendicular to the bottom of the recess and concentric with the rear main journal within .001 TIR. The surface roughness of the pilot bore must be not greater than 32 micro-inches Ra.

The new crankshaft gear should fit within the pilot without apparent looseness. The .0010 loose to .0005 tight fit (see Table 1) may seem somewhat tight, but the gear should be able to be seated with minor tapping with a brass or plastic face mallet. The inspections specified in SB 475C should be followed to ensure the gear is flat against the flat surface at the bottom of the recess. Bolt torque specifications and additional assembly information are provided in Lycoming Overhaul Manual 60294-7.

The crankshaft must be magnetic particle inspected when all repairs are completed but before the gear is permanently installed.
