# Service Information Bulletin

**Title: Effect of Over Temperature Operation and High Piston Blow-By on Cylinder Safety**

SIB No.: 12-2  
Page: 1 of 8  
Issued: 12/04/2012  
Revision: 0

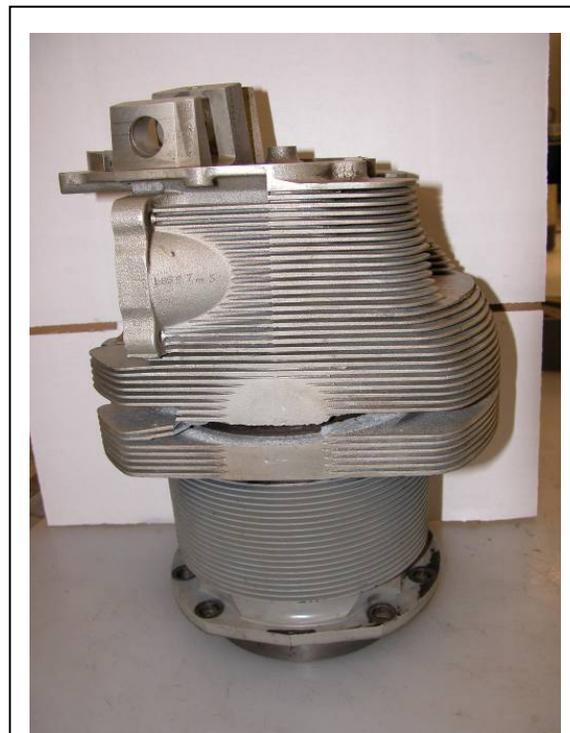
**Photograph 1**

The design of opposed aircraft engine cylinders for the majority of current engines have a cylinder head that is shrunk fit onto a cylinder barrel by heating the head and cooling the barrel before assembling them. Illustration 1 shows a cylinder cross section and cross sections of the head-to-barrel interface for Lycoming and Continental cylinders. Illustration 2 shows where many cracks initiate.

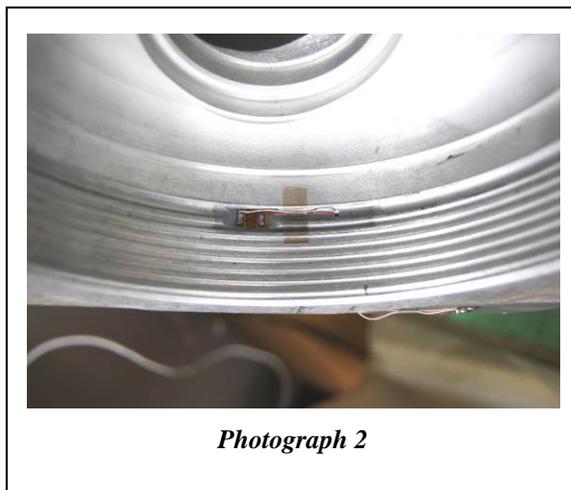
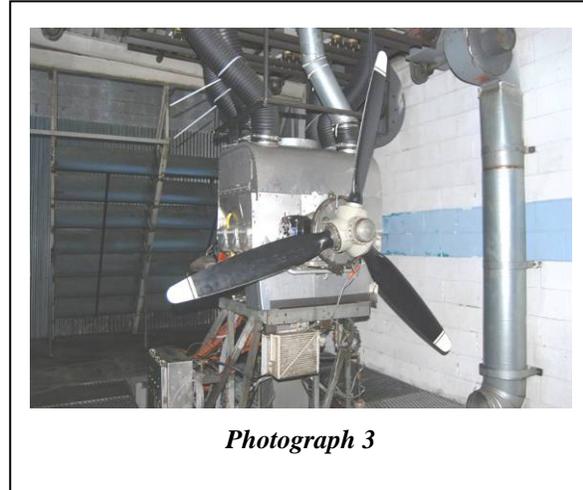
The cylinders were assembled and installed on a Continental TSIO-520-NB engine, which was then installed in an AEC test cell. Photograph 3 shows this engine in the test cell ready for testing. This test cell has individual controllable cooling systems for each cylinder, so very precise temperature control can be maintained during testing.

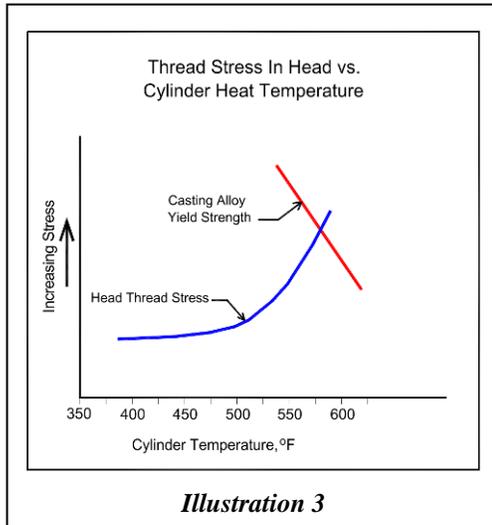
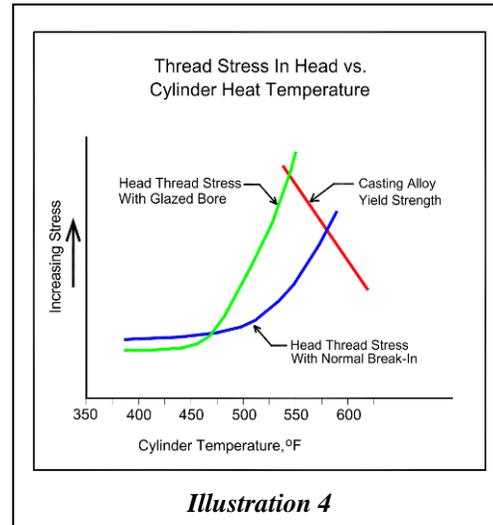
The test data was plotted and then analyzed to determine how the stresses varied with temperature. The test data showed that stresses at the threads increase rapidly when the temperature exceeds the published CHT limits, with stresses then increasing rapidly with increasing temperature. The aluminum head has twice the expansion rate with temperature as the steel barrel, and as the head heats up, . Loss of seal band friction allows the combustion stresses to pass by the seal band and concentrate in the root of the first loaded head thread. This increasing stress can be sufficient to induce a crack in the top loaded thread root. Illustration 3 shows the variation of stress just above the threads with temperature.

Investigations of cylinders that have cracked in the top loaded head thread have shown that the vast majority have also had high piston blow-by, which also causes a heavy varnish deposit on the barrel bores called “glaze”. Because of these indications, AEC conducted additional testing by installing an instrumented cylinder using a barrel and piston that had experienced high blow-by in the field. The cylinder assembly was controlled to insure that it was dimensionally similar to the cylinder it replaced. This test phase revealed that the stresses in the cylinder with high blow-by were significantly higher than the cylinder that it replaced as shown in Illustration 4. We now know that poor break-in or other operational issue that causes high oil usage from piston ring blow-by is not just a nuisance, but can also be a safety issue.
